Re: Sanitary Sewer System Compliance Evaluation Inspection Village of Kiryas Joel  
Village of Kiryas Joel WWTP SPDES Permit No. NY0250520  
OCSD No. 1 Harriman Plant SPDES Permit No. NY0027901

**SANITARY SEWER SYSTEM  
COMPLIANCE EVALUATION INSPECTION REPORT**

**Compliance Evaluation Inspection:** Village of Kiryas Joel Wastewater Treatment Plant Separate Sanitary Sewer System

**Inspection Date:** April 4, 2013

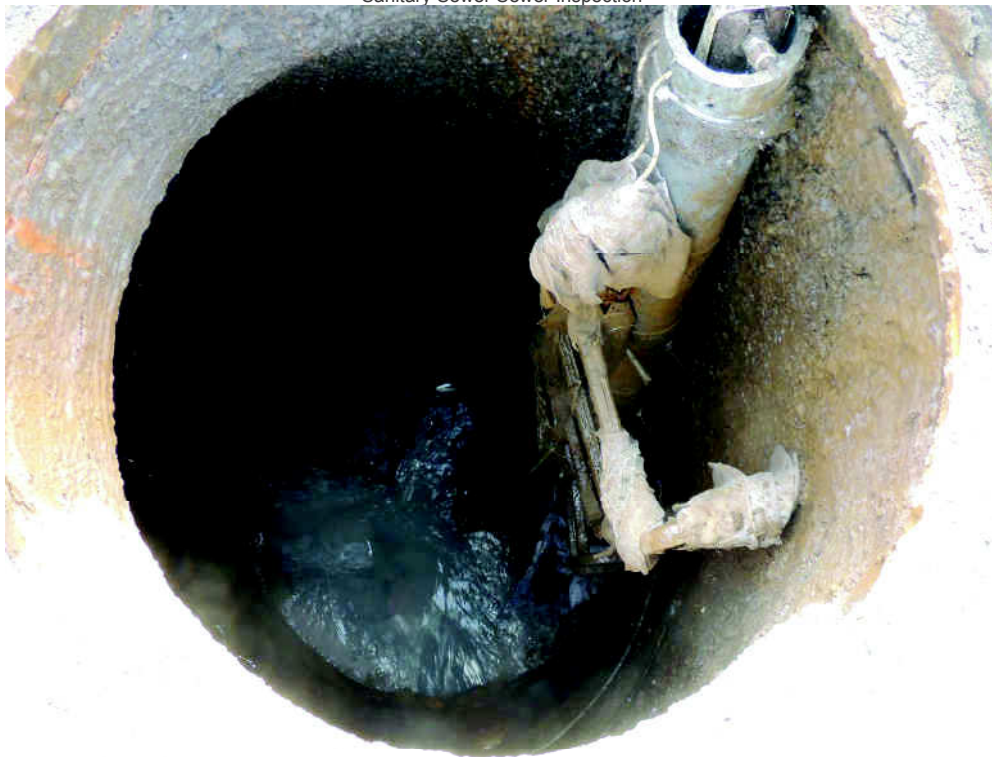
DSCN1220.JPG

<b>Photo ID No.</b>	<b>Photo Description</b>
DSCN1220	Manhole NW-17 - surge stick - to measure heights of flow was installed but not operating - debris and rags were seen within approximately 1" of the top of the manhole
DSCN1221	Manhole NW-12 - flow through manhole. Not surcharged. Debris was seen 1/3 of the way up the manhole chimney.
DSCN1222	Sanitary sewer manhole - flowing normally.
DSCN1223	Manhole on old, abandoned 12" line. Small rust colored flow, no sanitary flow, perhaps groundwater.
DSCN1224	Manhole NE-3 - rags seen up to approximately 3' from the top of the manhole.

3. As described in paragraph 17 above, the surge stick at Manhole NW-17 must be repaired so that levels of sanitary wastewater in the control manhole can be adequately monitored.
